4. TITLE (and Subtitle) Phase I Inspection Report National Dam Safety Program Overpeck Tidal Dam Bergen County, New Jersey	5. TYPE OF REPORT & PERIOD COVERED 9 FINAL + rept. 4

OVERPECK TIDAL DAM (NJ00799)

PHASE I INSPECTION REPORT
NATIONAL DAM SAFETY PROGRAM

Name of Dam:	Overpeck Tidal Dam
Identification No.:	Fed ID No. NJ00799
State Located:	New Jersey
County Located:	Bergen
Stream:	Overpeck Creek
River Basin:	Hackensack
Date of Inspection:	April 24, 1981

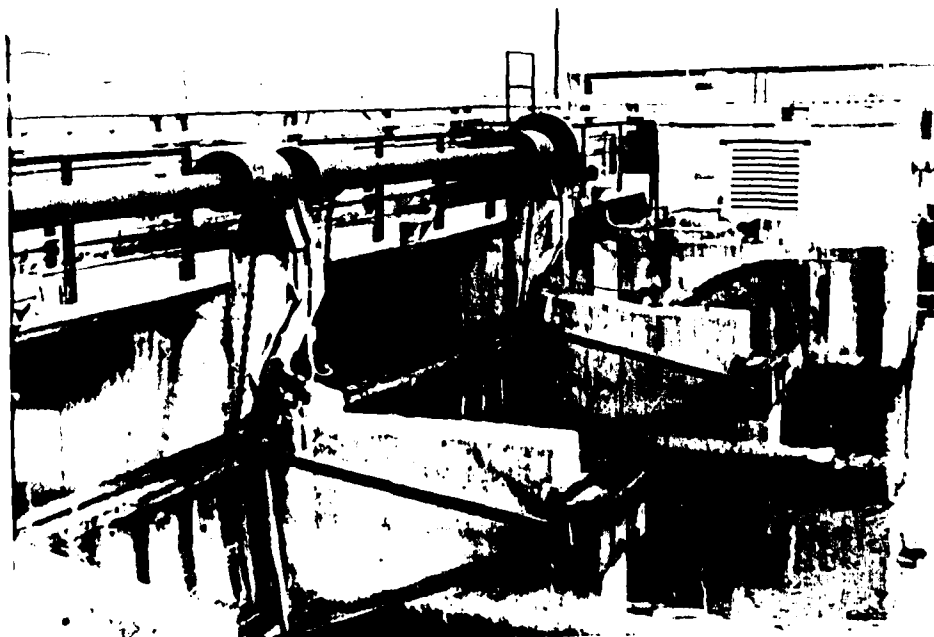
Control house and left side bascule gate and two Tainter gates.

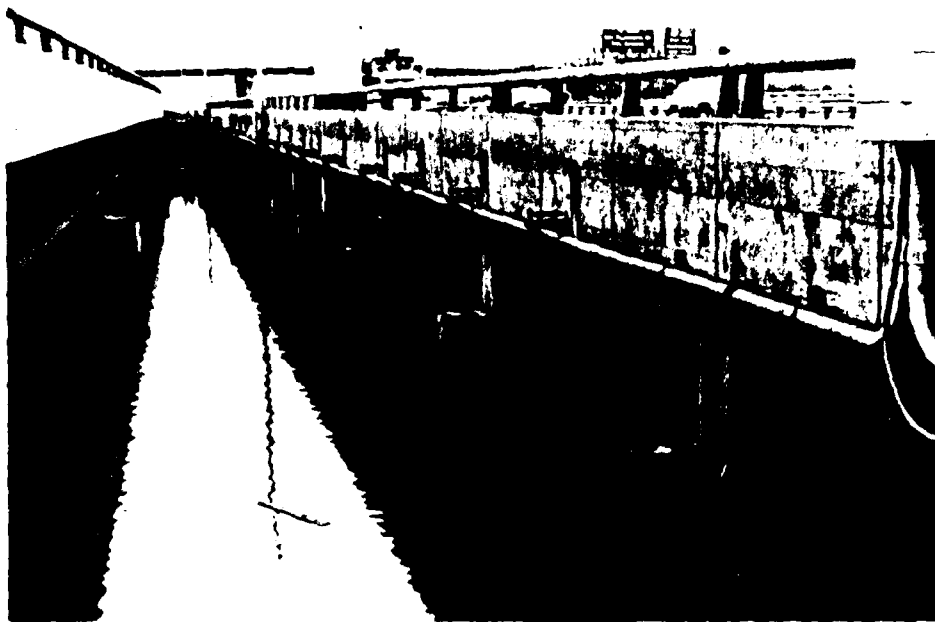
b. Appurtenant Structures. The steel stoplog supports are rusted at the waterline and the wood stoplogs are weathered. The concrete piers are surface eroded exposing the cause aggregate; and the steel sheeting along the upstream and downstream channel walls are rusted. The bascule gates, tainter gates and control building are all in excellent condition. No visible leakage was noted from any seal. The gates are operated automatically and were tested successfully. The emergency diesel generator was run and all instruments observed to be in working order. The generator is properly vented and housed in the control building. ←

Upstream stoplog sections. Caissons at right are used as part of right abutment for dam and bridge support. Note slots upstream in concrete supports for dropping temporary gates while servicing stoplogs or dewatering bays under bridge.

1. Inspect the erosion protection along the toe of the cofferdams on either side of the dam, both upstream and downstream, during low water condition, and design remedial measures, if required.
2. Evaluate the impact of the corrosion on the vertical steel stoplog supports and design and oversee remedial measures.
3. Evaluate the extent and impact of the deterioration of the concrete below the waterline of the piers.
